A STUDY OF ROADWHEEL FAILURES MAGNITUDE - NATURE -
CAUSES AND TESTING OF A CONCEPT TO PREVENT THEM

John W. Cameron

TECHNICAL REPORT NO. 12080

FINAL REPORT

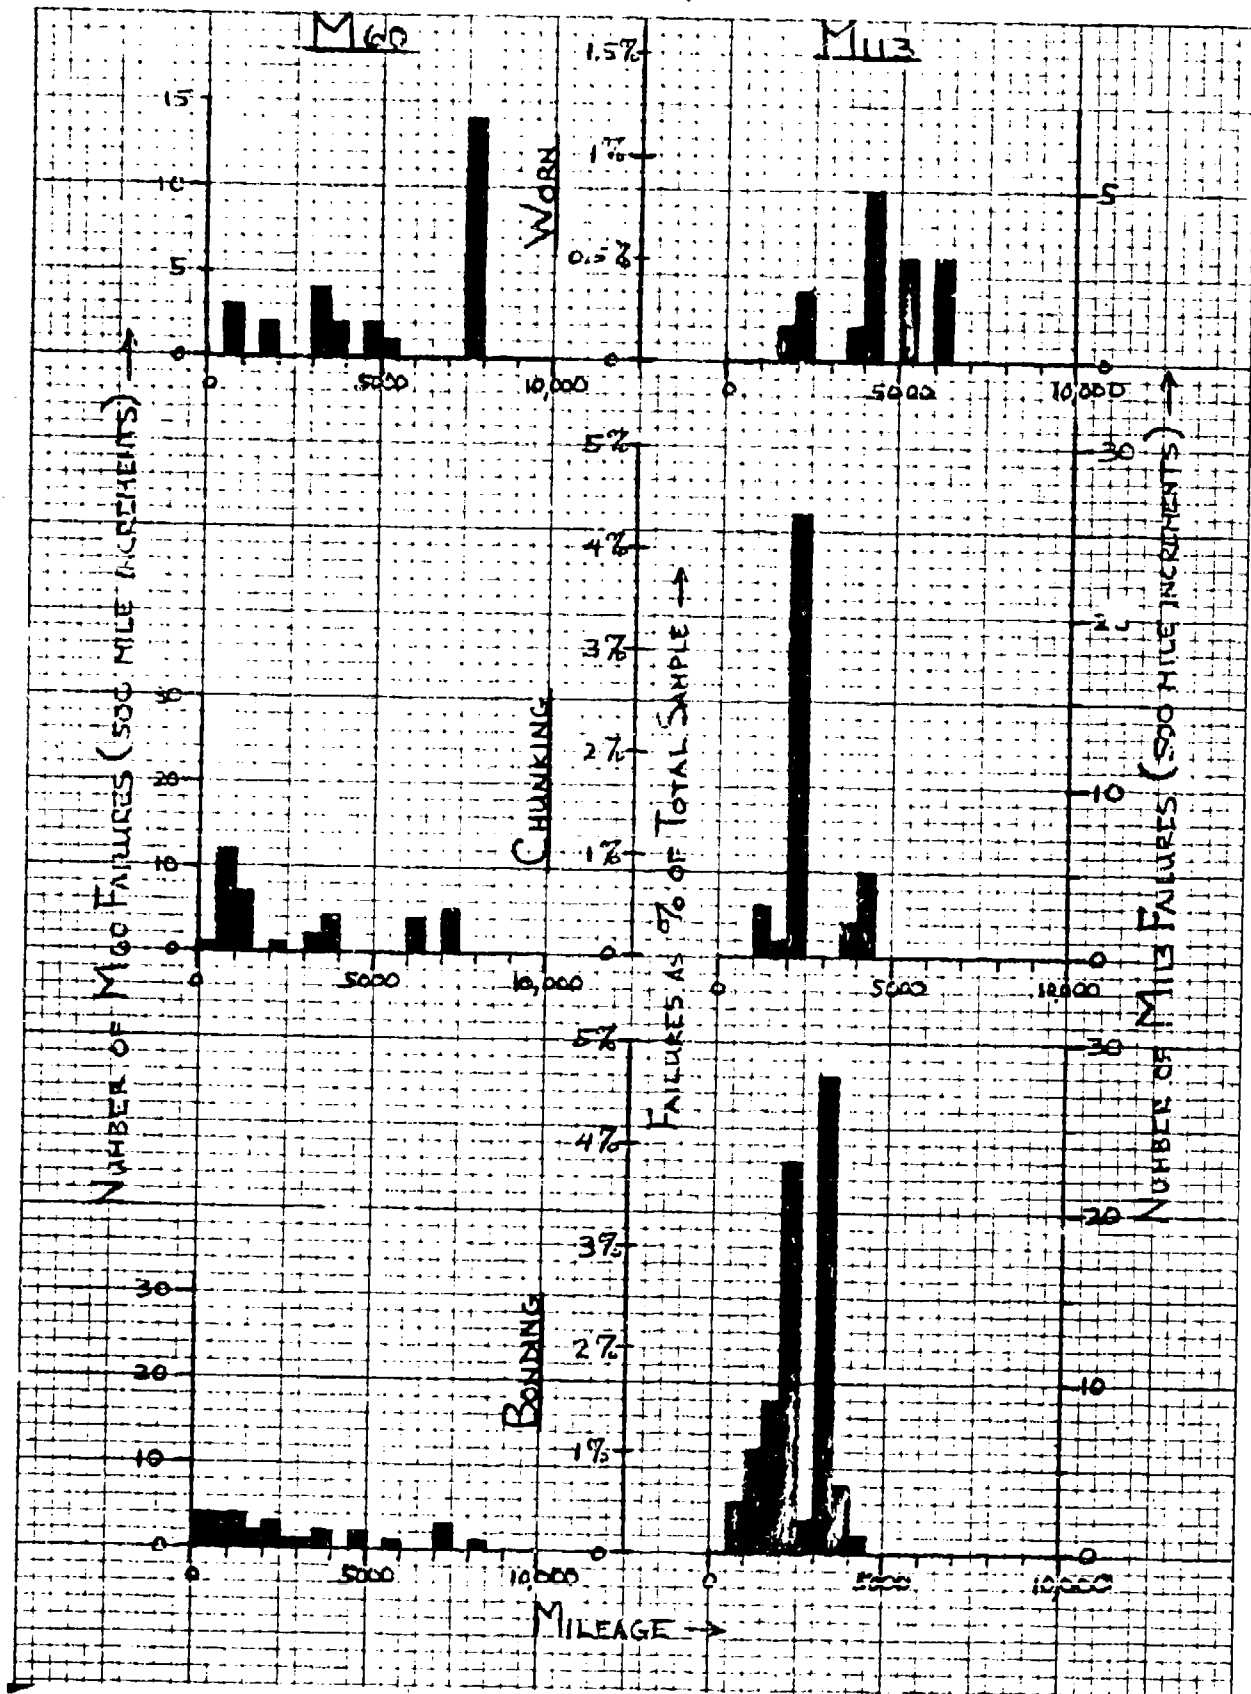
The data was further analyzed by breaking the failures down to 500 mile increments of life. They are shown on the bar chart on Page 9. The roadwheel failures are broken down into bonding failures shown in the bottom section, chunking failures shown in the middle section, and worn rubber failures shown in the section at the top of the page. The M60 data is plotted on the left hand side and the M113 data on the right hand side of the page. The vertical scale at the center shows failures as a percent of the sample and is common to both the M60 and M113 data. The vertical scales at the sides of the page apply only to their respective data and are not common since there are 1200 wheels in the M60 data and only 600 wheels in the M113 data. From left to right the life of the wheels has been broken into 500 mile increments.

First, consider the two bar charts on bonding failures. Note that the failure rate on the M60 is constant in the first three 500 mile increments and then generally declines. Now note that on the M113 there were no failures in the first 500 mile increment but then the pattern is one of steeply rising failures

in succeeding increments. The difference in pattern is striking! But why? Remember the rubber specification is much more restrictive on the M113 - especially with regard to adhesion. Past experience indicates that rubber processing is especially dependent on personal attention to detail for the maintenance of quality. Given these conditions, a supplier would naturally concentrate more personal attention on the M113 wheel than on the M60. As a result, one might receive a higher percentage of M60 wheels containing flaws such as foreign materials present on bonding surface, bare spots on rim which had been missed when applying bonding compound, improperly cleaned rim surfaces, etc., than would be found on M113 wheels. As the wheels were put into service these flaws would result in early failures, but as these wheels were thus eliminated the balance of the wheels would perform in accordance with design conditions. On this assumption, the M60 design appears to provide good resistance to bonding failures.

The M113 wheel, on the other hand, if it received special attention to meet the high quality requirements, would perform better in the initial 500 mile increment. Then as the effects of the additional shear stresses designed into the M113 wheel built up with each mileage increment one would expect the failure rate to increase as it does on the bar chart.

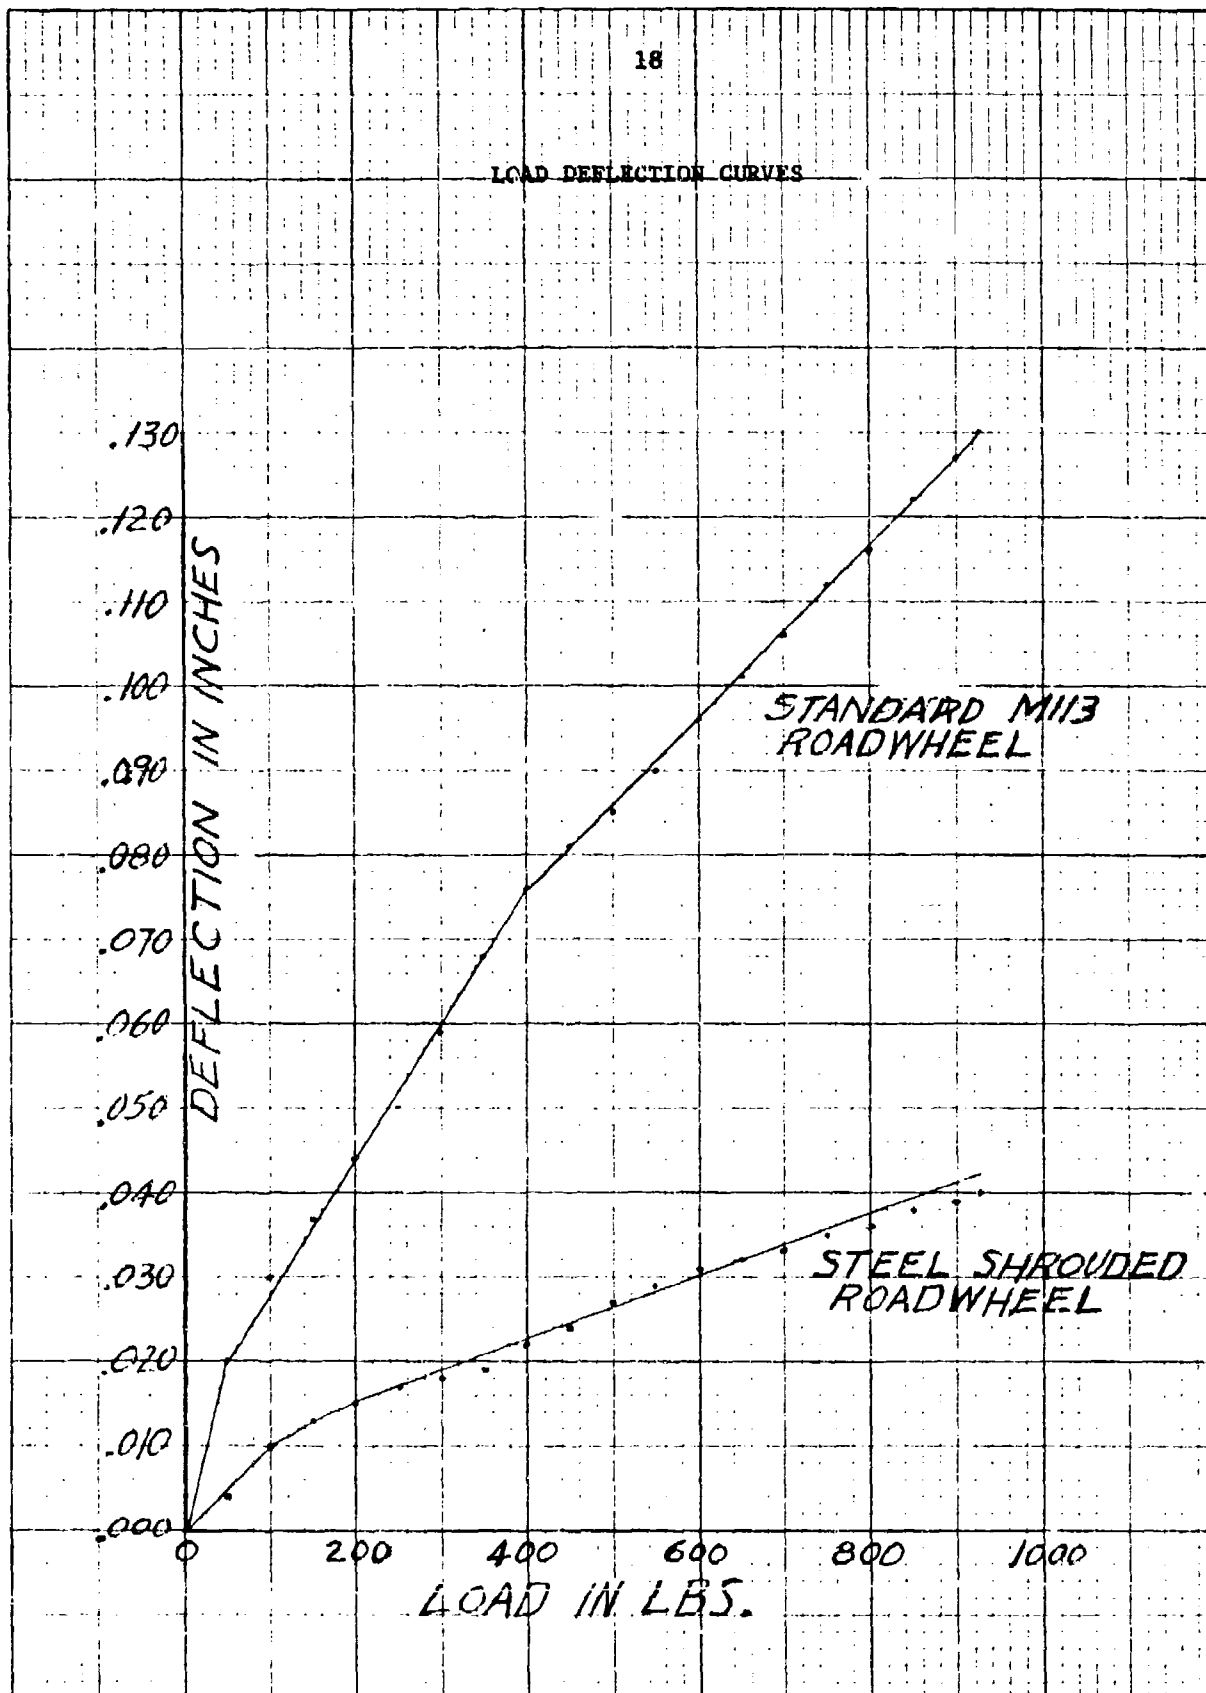
LOAD DEFLECTION CURVES

Load-deflection data was taken in the laboratory on the steel shrouded wheel and on the standard M113 wheel. The curves have been plotted for comparison. The objective was to see if load deflection data could be used in lieu of vehicle field tests to indicate probable ride characteristics. In this respect it is interesting to note that the load deflection curves show the

steel shrouded wheel to be three times as stiff as the standard wheel. For low speeds on the dirt track, the Table of Amplification Factors shows the same magnitude of increased stiffness. It should be remembered that the tire is only one of the springs. The other spring is the vehicle suspension spring and these two springs are in series. The accelerometers recording ride quality are of course on the vehicle hull. It is felt the correlation shown for low speed on the dirt track is significant. If this would prove to be true on several more tests it would be a valuable tool and could save much cost by making full vehicle field tests less necessary in evaluating wheel candidates.
